Manhole Inspection Summary

Manhole # S19A1_001MH

Location Address: **2415 toley st**

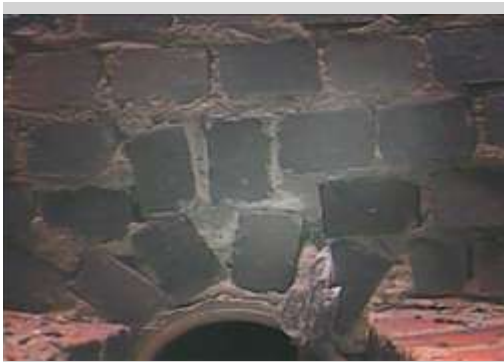
Defect 5

Condition: ☐ Sound ☒ **Cracked** ☐ Root Intrusion ☐ Loose Brick ☐ Deteriorated

cracked barrel mortar with ragging deposits attached

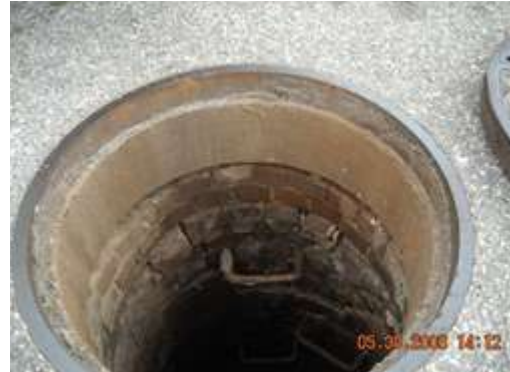
Defect 4

Subject To Ponding: **Sheeting**

☒ **Leaks**

Frame leaks-inflow evidence from sheeting

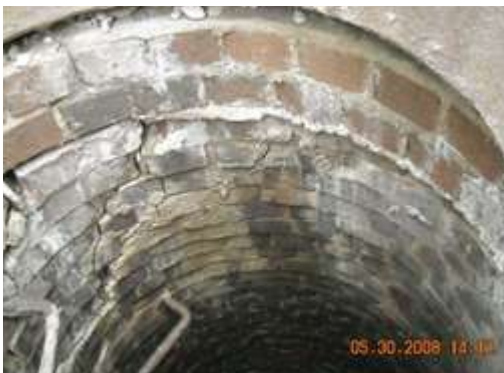
Defect 3

Infiltration: ☐ None ☒ **Joint** ☐ Cracks ☐ Mortar ☐ Roots ☐ Wall

infiltration @ corbel/chimney joint

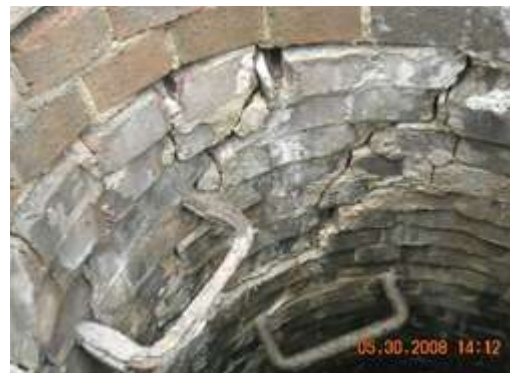
Defect 2

Condition: ☐ Sound ☒ **Cracked** ☐ Root Intrusion ☐ Loose Brick ☐ Deteriorated

cracked corbel bricks

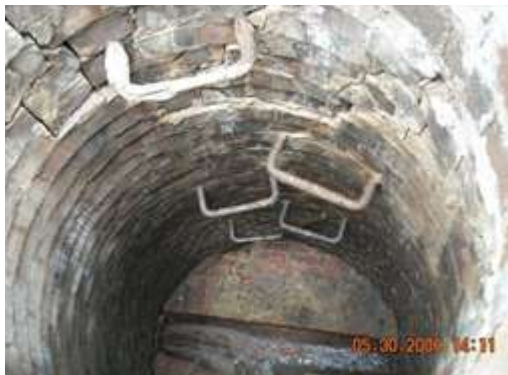
Defect 1

Count: **5** Missing: **0** ☒ **Corroded**

corroded steps

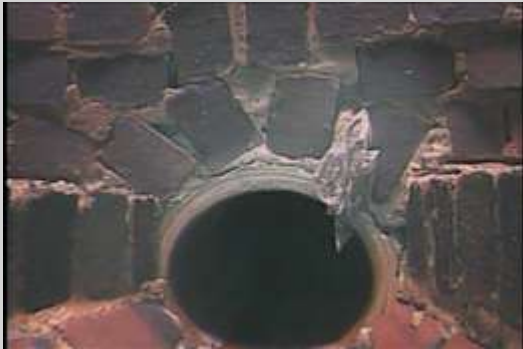
12 O'Clock Outflow

Pipe Height: **8.4** (in.) Rod and Bar (Angled)
Pipe Material: **Clay** ☐ Pipe Lined
Invert Depth: **10.06** (ft.) Flow Characteristics: **Slow**
Deposits: ☒ None ☐ Mud ☐ Sludge ☐ Debris ☐ Grease
Silt Depth: **0** (in.) Deposits Extent:
Infiltration: **None** Pipe Seal Cond: **Cracked**

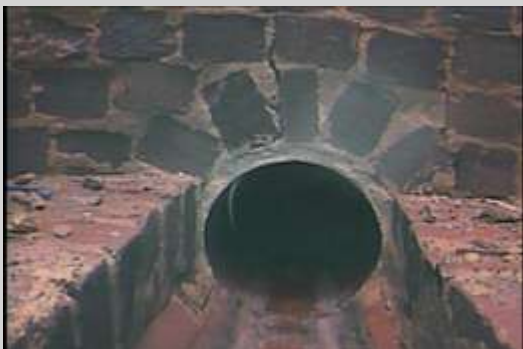
6 O'Clock Inflow

Pipe Height: **8.4** (in.) Rod and Bar (Angled)
Pipe Material: **Clay** ☐ Pipe Lined
Invert Depth: **9.61** (ft.) Flow Characteristics: **Slow**
Deposits: ☒ None ☐ Mud ☐ Sludge ☐ Debris ☐ Grease
Silt Depth: **0** (in.) Deposits Extent:
Infiltration: **None** Pipe Seal Cond: **Cracked**
